**PARETI DIPINTE  
AIPMA XIV  
9-13 settembre 2019**

## **lovía (Pannonia): painted walls of a late Roman palace complex**

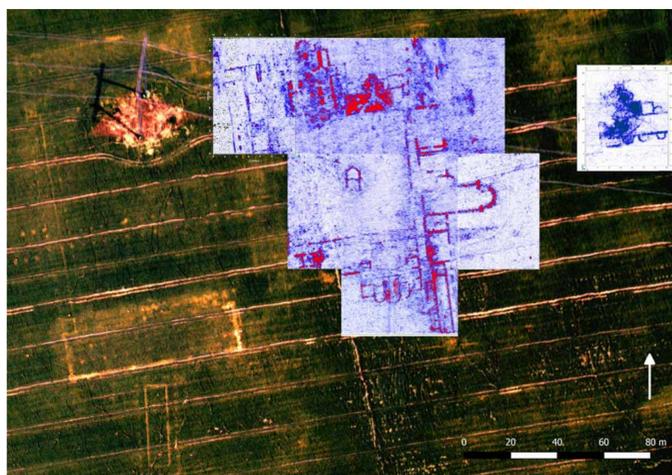
1. Part of the palace complex (Aerial image, Ground Penetrating Radar) (G. Bertók).

The remains of the palace complex from the 3<sup>rd</sup>-4<sup>th</sup> century are located in the southwest of Hungary (Szakcs/Dalmand-Gölösi dűlő). Within an about 600 x 600 metres area once surrounded by walls there were buildings of different function (a double peristyle, several times reconstructed palatial building complex ca. 80 x 160 m including a large aula 10 x 30 m in size, a bath, and a 200 m long colonnaded road connecting the main building and the western gate, and various other buildings for storage, etc.). The site has been examined by Pázmány Péter Catholic University's "lovía Research Project" led by Gábor Bertók, since 2013. With the help of remote sensing data, it has been possible to create a preliminary map of the remains that could be refined by ground penetrating radar and magnetometer survey and excavation. According to the latest results of the *lovía* research project, the size and the layout of the building complex, together with special finds, like porphyry slabs (SOLT) suggest that the site may have been an imperial residence (**fig. 1**). During archaeological excavations that began in 2016 part of the once painted corridor or porticus bordering the eastern inner courtyard of the double peristyled building was explored. Wall painting surfaces of the bottom band were still on the stone wall but large quantities of fragments were found in the debris.

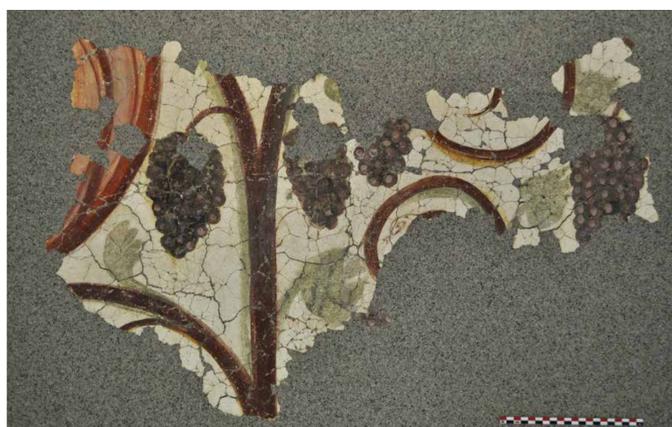
2. Human figure in a grape arbour. Restored wall painting detail (E. Harsányi).

The one near the figure, whose pink-red dress is only partly visible, shows grapes painted in pink on a white background (**fig. 2**). There are two other assembled surfaces on which the grapes are blue on a different background modelled in ochre. On these surfaces, which belong together but still are not connected, a painted figure appears as well. The smaller than life sized man in tunic holds a wooden stick perhaps with a metal handle. If this is a tool used in viticulture then the parallel of this picture might be found most probably among genre paintings and not among mythological scenes. According to the fragments' location in the debris it could be determined that the blue coloured grapes were to the right of the pink ones (**fig. 3**).

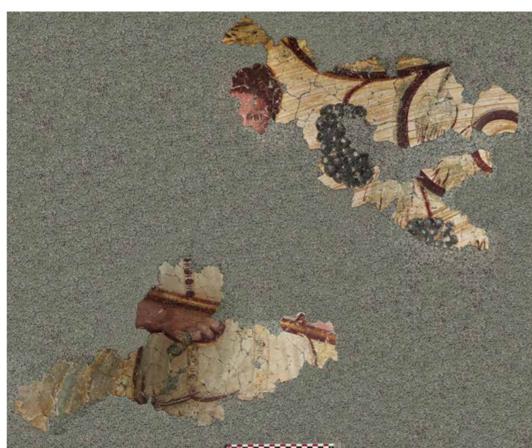
3. Human figure in a grape arbour. Restored wall painting details (E. Harsányi).

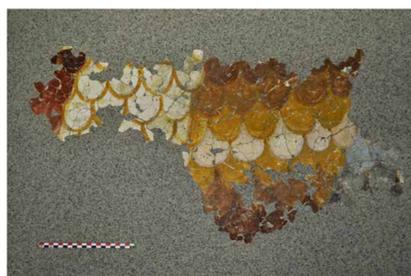
4. Ornamental carpet motive with "scales": Restored wall painting details (E. Harsányi).

An ornamental carpet motive with "scales" was originally placed somewhere on the wall, too. Lining imprints in the plaster that gives the heights of the scales can be seen in directed lights. These lines were then emphasized with yellow paint, the same used to sketch the "scales" and other motifs onto the wall. The nine rows of "scales" that are known so far are painted with different colours in slightly oblique sections widths of which are 4-5 "scales". In a section the tones of the "scales" are different by rows. The ones in the middle are the lightest then gradually darker and darker rows follow in two directions (**fig. 4**). The flat ceiling of this section of the peristyle or corridor was covered with a colourful geometric pattern based on a square grid system of yellow stripes. The squares between the stripes are diagonally subdivided into white and red. Where the yellow stripes cross there are black circles with blue internal paint and a black dot in the middle (**fig. 5**). The ceiling was covered not only with the mentioned pattern but with other carpet motifs as well. East of this there was a floral ornament with large size stylized petals.

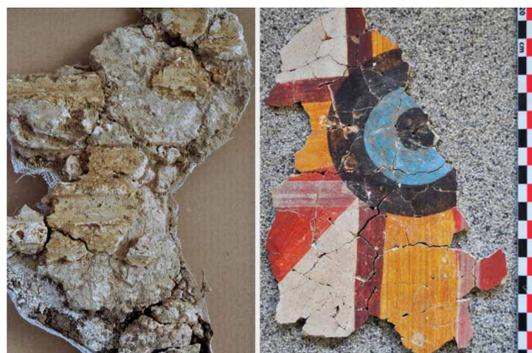
5. Geometric pattern and imprint of the wicker construction of the ceiling on the reverse (E. Harsányi)

The wicker construction of the ceiling based on the imprints on the reverse was made with wattle woven between the laths that fixed perpendicularly to the roof beams (**fig. 5**). The thickness of the plaster which the painting is applied on is 4,5-6 cm. Basically it is of three main parts but totally it might consist of five or six layers. The lime and sand mixture layers are in different condition. The first layer on the stone wall is in good condition, its surface is relatively smooth. Onto this layers, after drying another two layers of mortar was applied which today are so weak and crumbly that they can be swept off.
